Weekly Summary Report

USEPA Oversight, Sauget Area 2, Sauget, IL

Week Ending Friday May 7, 2004

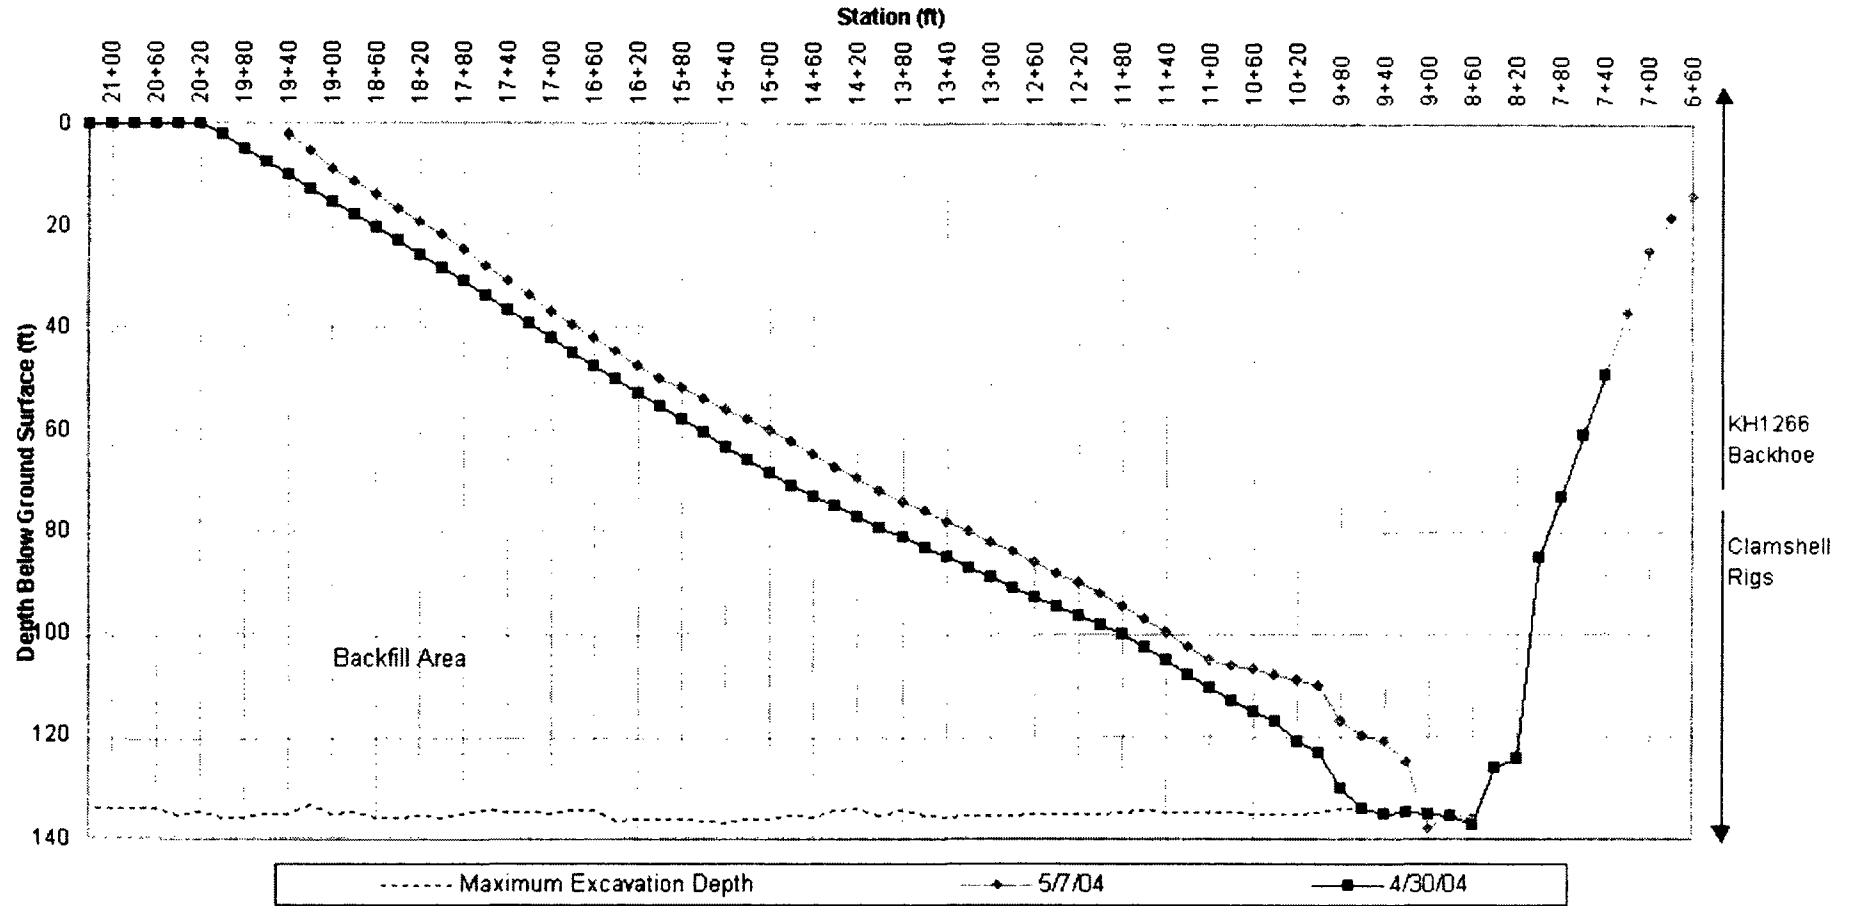
**Graph 1 - Weekly Barrier Wall Construction Progress
May 3 through May 7, 2004**

Note: Data plotted for the week through PM measurements on 4-30-04 and AM measurements on 5-7-04.
Some data points are interpolated between the available data points where trench depth measurements were read.

During the week, the trench depths were generally measured once at the end of the day except for May 3, when an additional measurement was made in the morning. The afternoon trench depth measurements were made every 100 linear feet of trench, with 20-foot spacing of measurements on either side of the backfill toe. The trench depth measurements from the afternoon of May 7, after the backfill placement into the trench, are shown in Table 2. The trench profile is depicted in Graph 1, and is compared to the trench depth profile measured end of the previous week (April 30). Graph 2 shows the overall progress of the barrier wall construction.

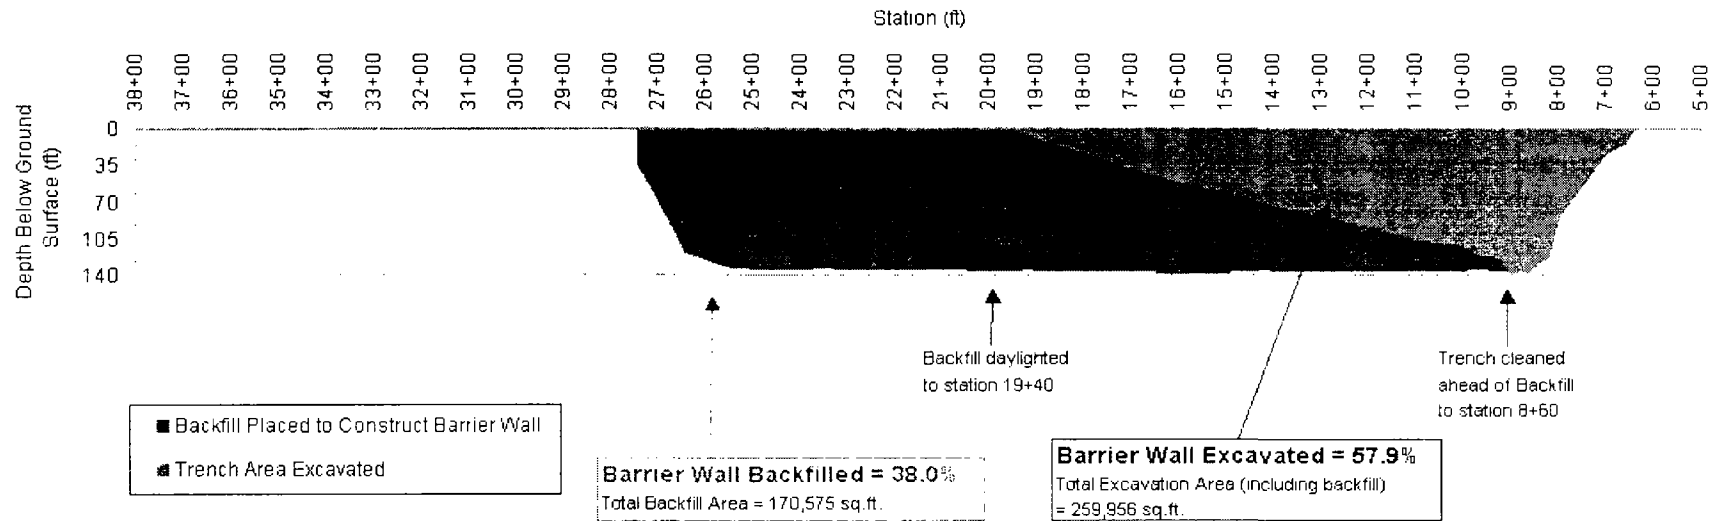
Graph 2 - Barrier Wall Construction Progress by May 7, 2004 (PM)

Note: Data plotted for week through PM measurements on 5-7-04.

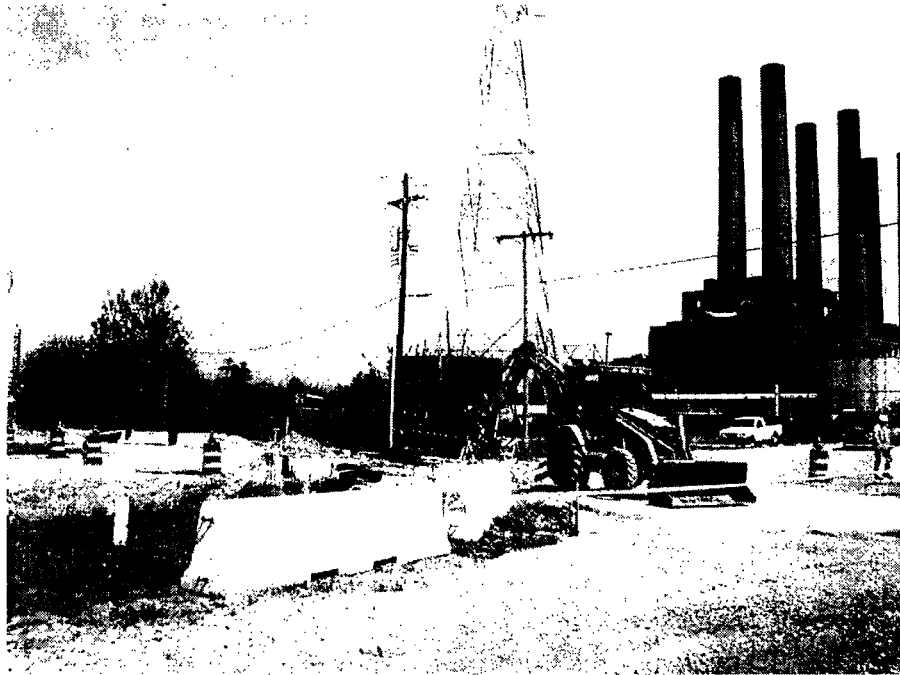
Pretrenching for underground utilities at the north leg of the barrier wall alignment (May 4, 2004).

Pangea was onsite, pretrenching at the north side of Site R to prepare for future barrier wall excavation. A small backhoe was used to excavate the barrier wall footprint to a maximum depth of ten feet to explore the underground utilities. The trench was backfilled later with soils/fly ash excavated from the pit.

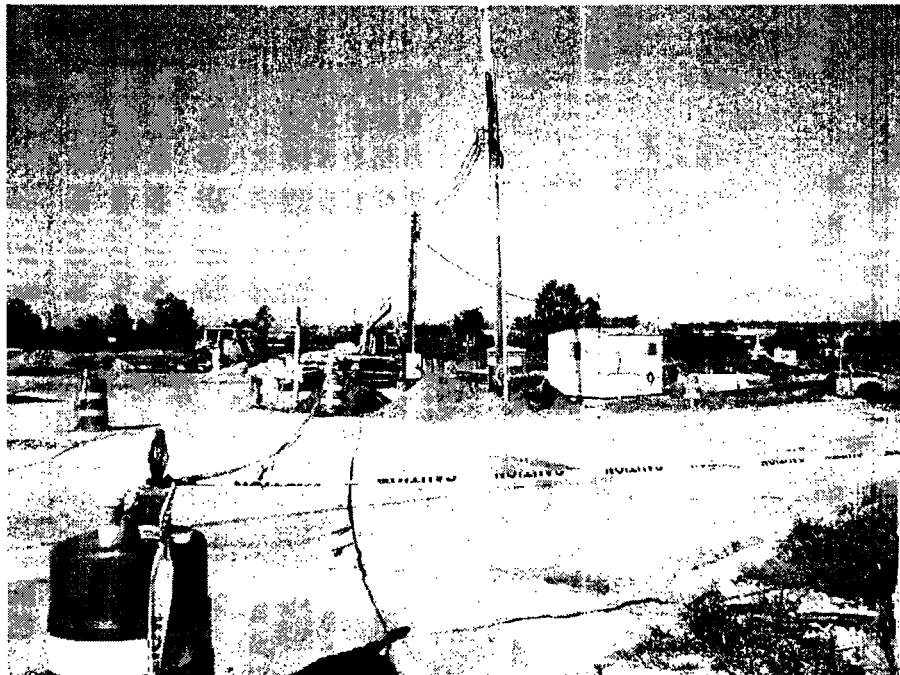
Site preparation at the north portion of Site R (May 5, 2004).

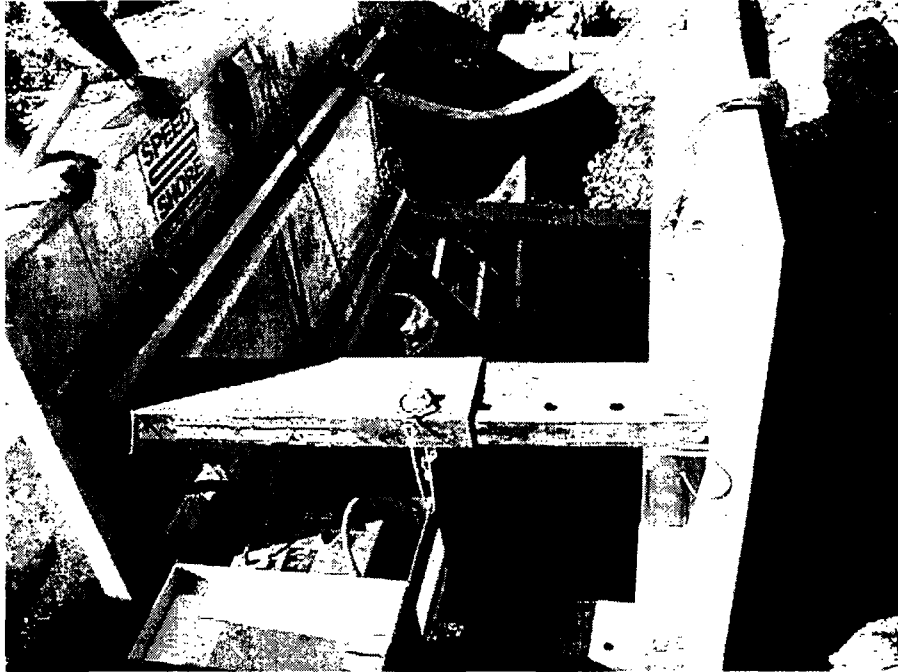
Cutting off a 2-inch diameter water line across the Riverview Road (May 5, 2004).

Utilities encountered along the barrier wall alignment thus far on Riverview Road included a benzene line (six-inch in diameter, inactive), four water lines (two two-inch, one six-inch, and one 12-inch in diameter), one underground electricity line, one phone line, and one box culvert. The two-inch water line was partially removed by Rockhill personnel at a section across the barrier wall alignment. Confined space permits were issued by Solutia on two days of the week for the removal of the two-inch water line since the depth of the excavation pit was about six feet. The removal of the box culvert was completed by Pangea at the beginning of the week.

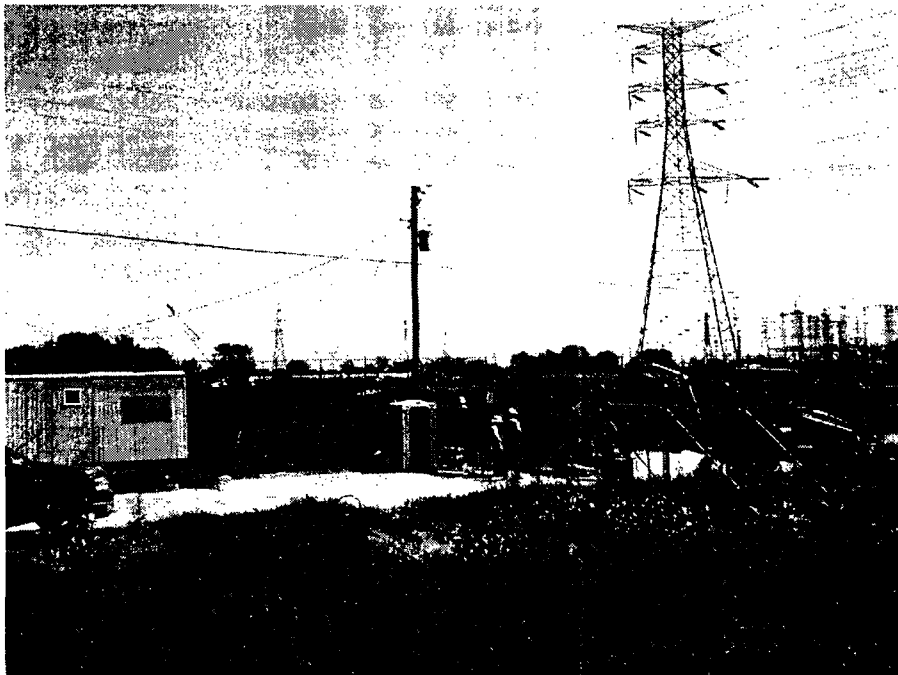
Pretrenching for underground electricity line near the guard trailer (May 6, 2004).

Lowry Electric, assisted by AmerenUE, converted an aboveground power line near the GMCS control building to an underground power line. A four-inch diameter conduit was installed to encase the power line after the conversion was complete. The underground electricity line near the security guard trailer was also encased with a two-inch diameter conduit. Note that electricity was shut off for approximately three hours because of the power line conversion.
